ThermoProbe, Inc.

Model TP8 USER MAINTENANCE

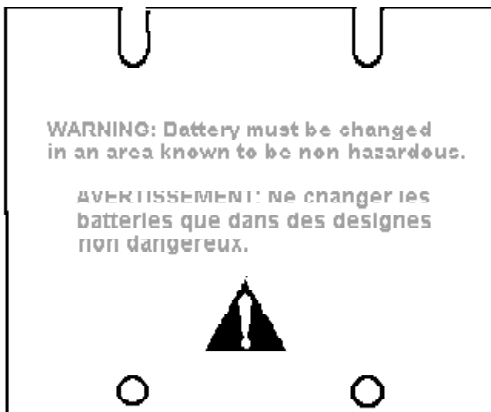
Remove the screws and plate to access the battery.

BATTERY REPLACEMENT PROCEDURE

PERFORM BATTERY REPLACEMENT ONLY IN AN AREA KNOWN TO BE NONHAZARDOUS.
APPROVED BATTERIES. See Identification plate for approved batteries.

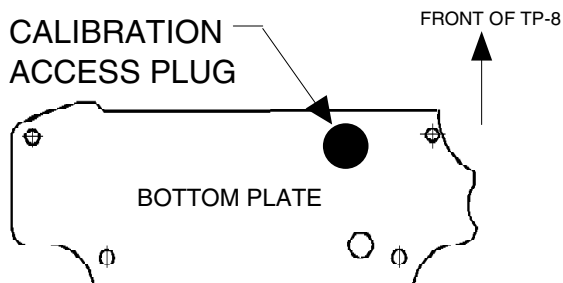
1. Remove the Calibration Access Plug as shown below.
2. Using the illustration (to the right) find the adjustment trims.
3. Adjust the ZERO with the probe assembly in Bath 1.
4. Adjust the SPAN with the probe assembly in Bath 2.
5. Repeat several times or until no adjustment is necessary.

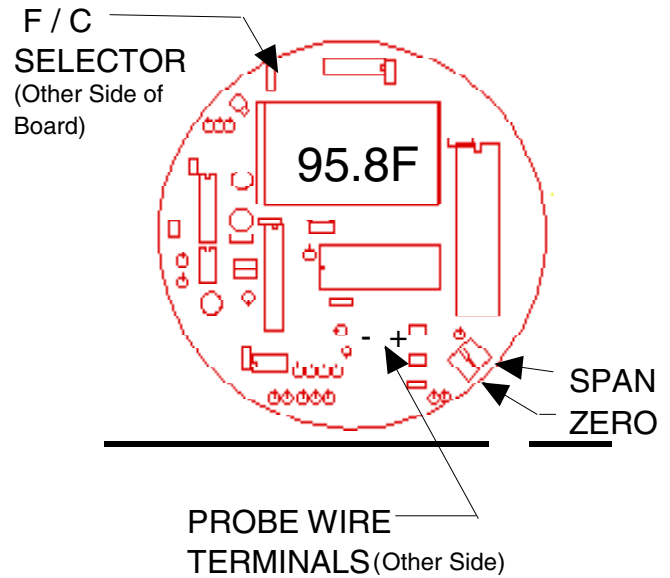
FACEPLATE-CIRCUIT BOARD MODULE

The TP8 may display the temperature reading in Fahrenheit or Celsius units. To change the readout from one unit to the other remove the switch plate and slide the circuit board through the top. The selector is located above the battery and the letters F and C can be seen on the surface of the board. Place the selector shunt on the center and upper pin for °F and center and lower pin for °C. See illustration on next page. There is no need for recalibration if there is a change in the temperature units.

Polarity markings are located on the circuit board in front of the finger connector. See illustration.

Black Wire (shielding with shrink wrap) = (-)
White Wire (signal lead) = (+)
